NATIONAL REGISTER OF HISTORIC PLACES REGISTRATION FORM

historic name: **Olsson, Don E., House and Garage**

other name/site number: **Olsson-Rohr-Winchell House; 503 4th Avenue, SW**

street & number: **503 4th Avenue, SW**

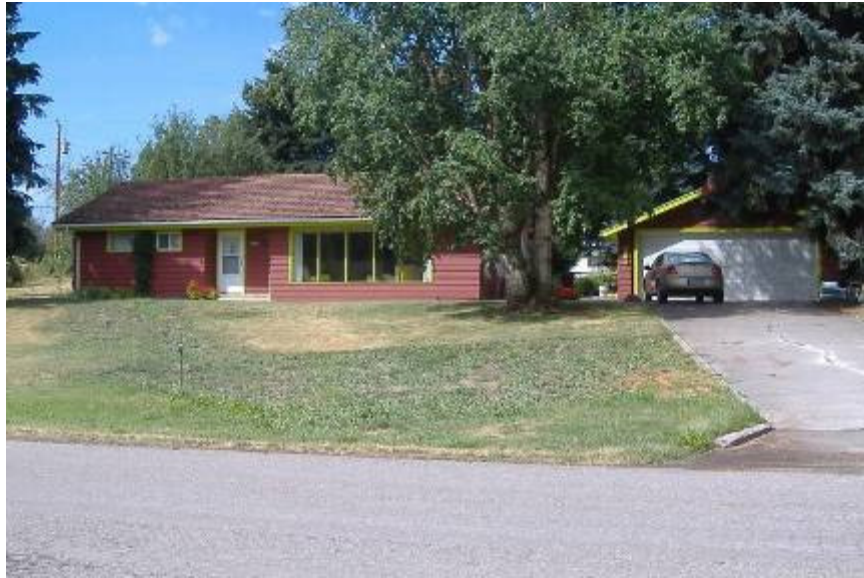
1. East façade house and garage looking west.

The façade is characterized by an inset entrance stoop one step above the walkway. The south wall of the entrance is perpendicular to the walk and the north wall is diagonal to give full visual acknowledgement of the entrance from the driveway. Between the entrance feature and the northeast corner are five large vertical Thermo-pane windows within wooden mullions. The windows, which light the living room, extend from nearly floor level to the eave soffit. South of the entrance feature is a band of ribbon windows with two openings with fixed lights and one opening with sliding sash that typically replaced an awning style window. It is believed that the sliders were installed sometime after 1978. Typically, the windows openings have flat board trim with a one-by-one fillet on the outside edges. A drip cap is located above each. The sills are plain without aprons and receive the trim of the jambs.

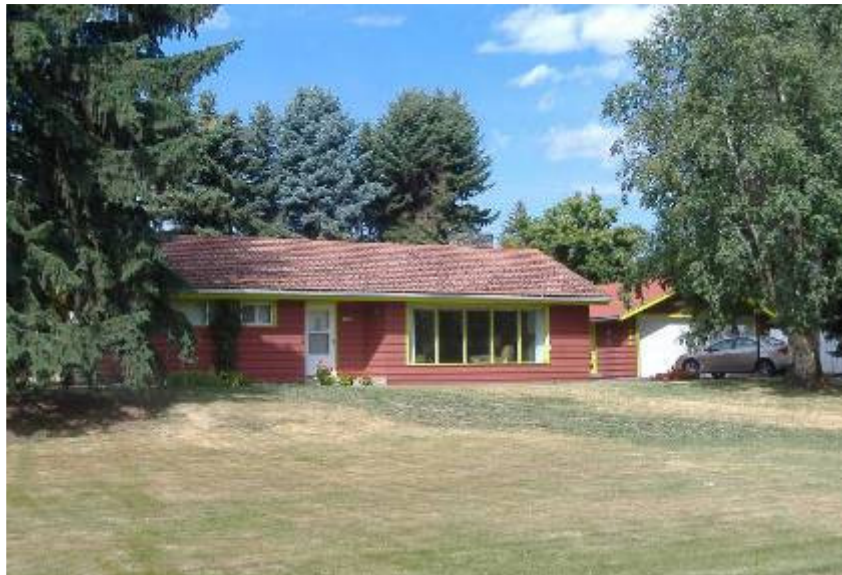
2. East façade of house and garage looking northwest.

Located approximately twelve feet from the house is the gabled roof, two-car garage designed to match the architecture of the house. A modern 32-panel overhead double garage door, extends partially into the east gable end. A doorway, with a solid core, flush panel door, is located near the east corner on the south elevation. There are no openings on the west gable end and the north elevation.

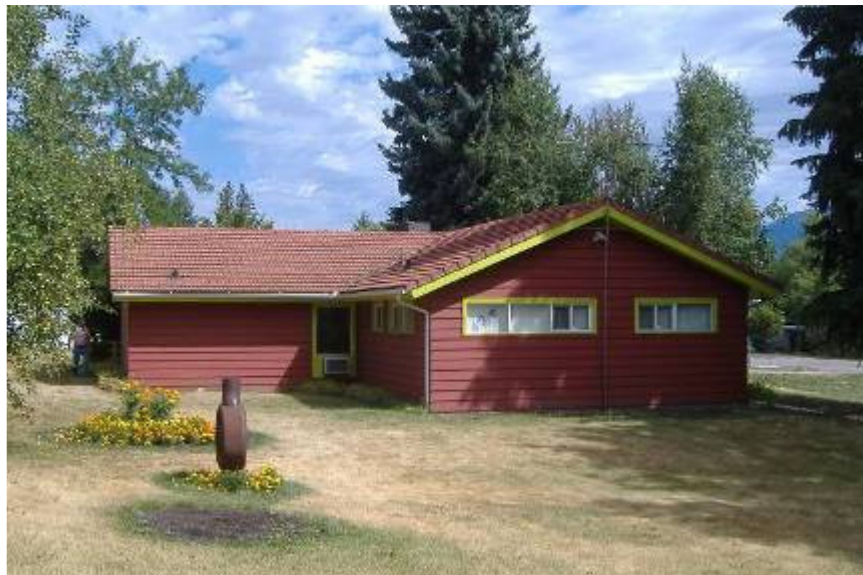
4. South elevation of house looking north.

The south elevation has two ribbon window openings of similar design. The eastern ribbon has two openings, one with fixed sash and one with sliding sash. The western ribbon has three openings with two fixed sash and one slider opening. The cedar siding extends into the gable end to a metal louver set into the apex.

At the south elevation of the rear wing, there is one large opening set into the cedar siding near the west wall. This window, which lights the dining room and was installed in 1954, has a large fixed sash in the upper section and a narrow bottom section presently infilled with an air conditioner. Originally, the bottom opening had an awning style sash.

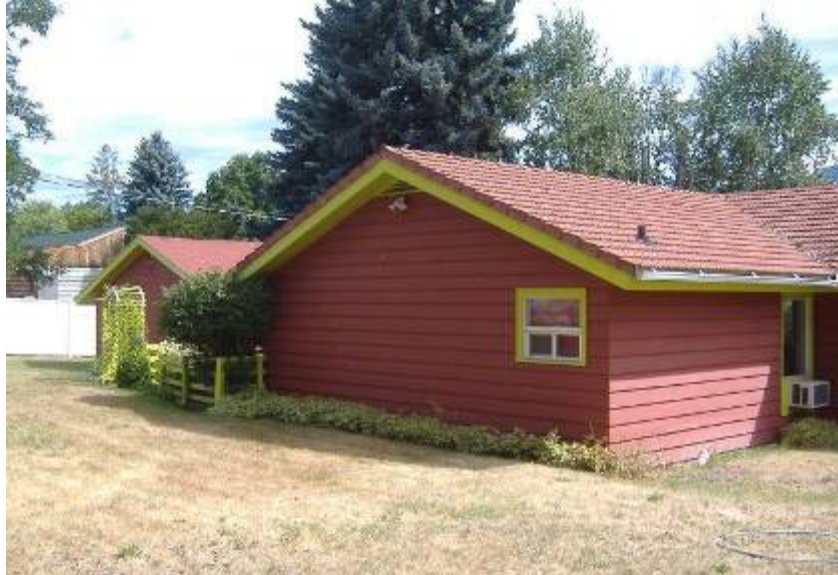
5. West wing looking northeast.

The eaves of the south elevation of the wing merge into the eaves of the west elevation of the original house that has two sets of ribbon style windows set into the siding. The south has two openings, one with fixed sash and one with sliding sash. The other is a sliding sash lighting the original bathroom.

At the west gable end of the wing, there is a single opening near the south corner that lights the master bathroom. It has a fixed upper light and a sliding sash in the lower light that replaced an awning style window. Similar to the south gable, the cedar siding extends to a louvered vent set into the apex.

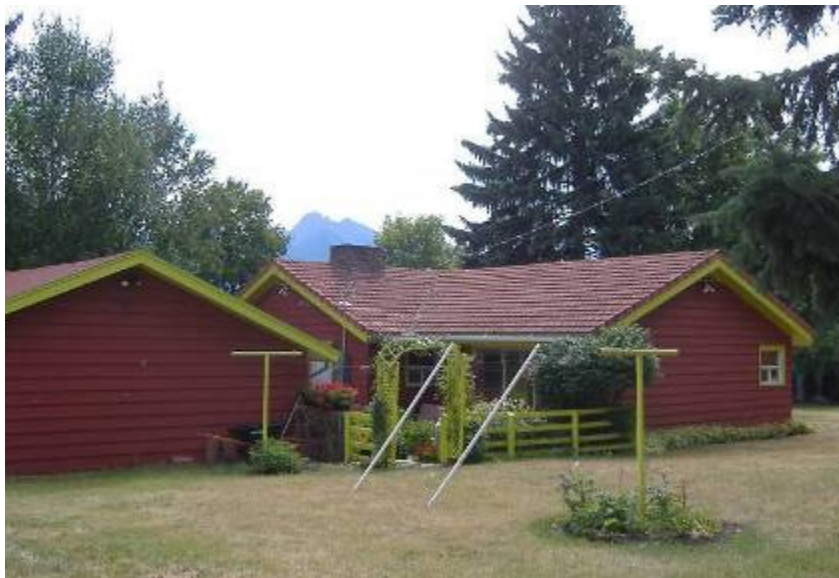
6. West elevation of garage, and west and north elevations of house looking southeast

At the north gable end elevation of the original house, there is a doorway near the west corner with a modern glazed door. Adjacent to it is a sliding window lighting the basement stairway. Like the opposite south gable end, the cedar siding extends to a metal louver set into the apex.

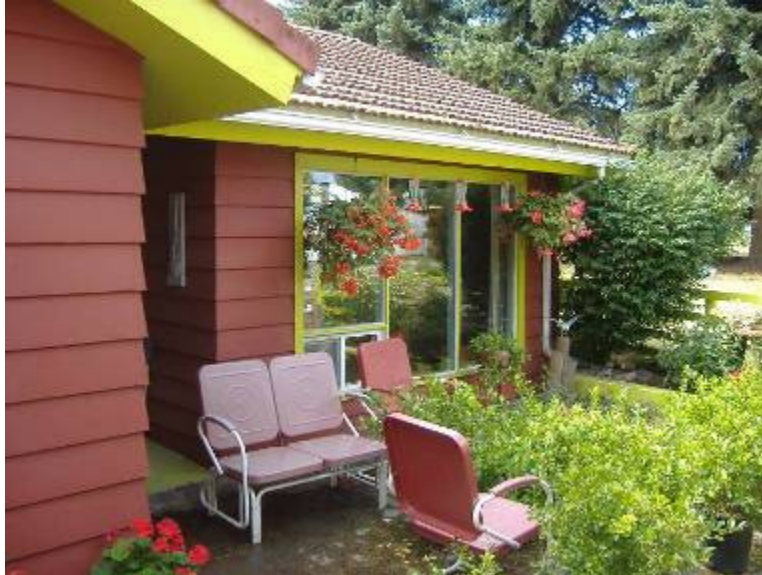
7. North elevation of west wing looking southwest.

The north elevation of the wing has three large vertical Thermo-pane windows that extend from nearly floor level to the soffits of the eave and light the master bedroom. The eastern window has a slider set into a lower opening that replaced an awning style window. Set back into a reveal is a doorway providing access directly to the dining room; a modern glazed door is in the opening.

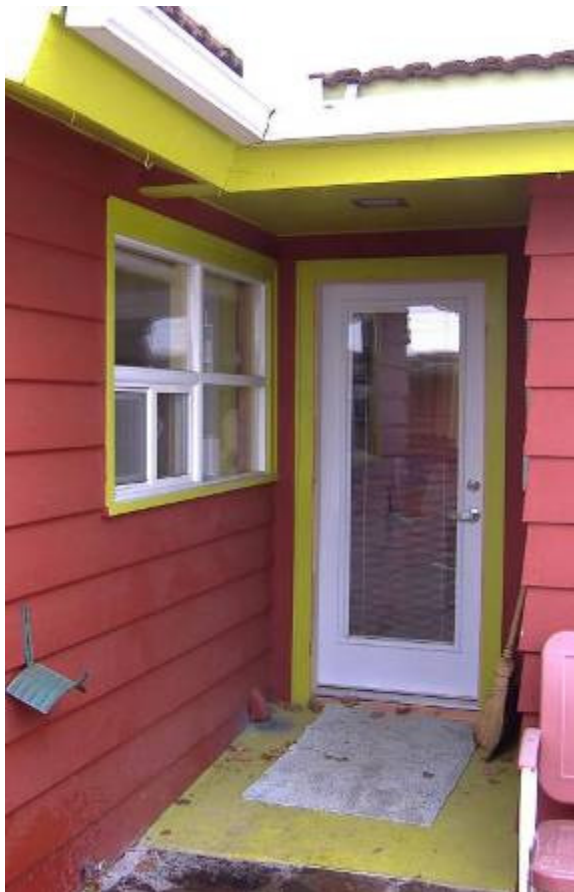
9. North elevation showing dining room doorway alcove and kitchen window looking south.

At the extended original west wall of the reveal is the kitchen window. A horizontal mullion extends across the center mullion dividing the opening. The north lower opening has sliders; all other openings are fixed.

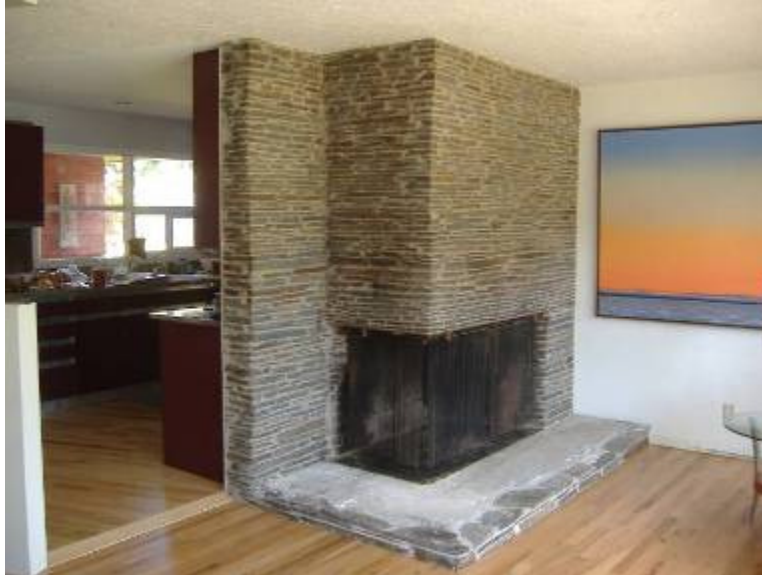
12. Living room fireplace looking northwest.

The Olsson House originally was built as a two-bedroom, one-bath residence with an open living room, kitchen, and small dining area. Original owner Don E. Olsson reported that there also was a small office near the bathroom in what is now the dining room. Below the original house is a basement containing a recreation room and laundry, furnace and storage rooms. The wing addition, that included enlarging the dining room by nearly one-third and adding a master bedroom suite with a three-quarter master bathroom, was built on a concrete slab. As a custom built house there are built-in wardrobes flanking drawers in each of the two original south bedrooms. Of similar construction is a built-in buffet in the south wall of the dining room that has cupboards surrounding open shelves. Opening from the dining room is the master bedroom suite. Separating the living room, which opens to the entrance vestibule and coat closet, from the dining room is an offset right-angled half partition set with four-by-four columns extending to the ceiling. The most distinctive feature of the house is the living room fireplace set into the northwest corner of the room. Constructed of carefully laid ledge stone in random horizontal courses, it has a shallow raised hearth and the firebox is open on two sides, which face into the room. The chimney stack extends from the hearth to the ceiling as a solid mass above and to the north of the firebox and is anchored with a ledge stone wing wall that extends south from the hearth to the ceiling.

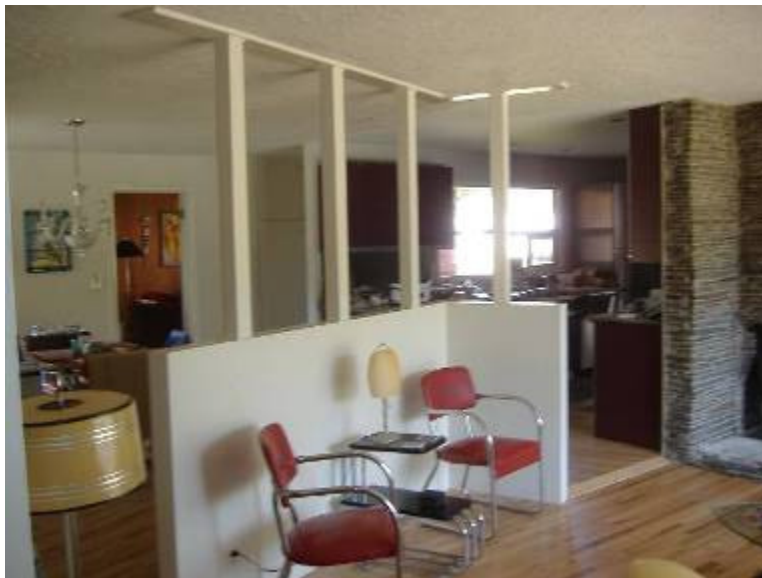
13. Partition between living room and dining room looking northwest.

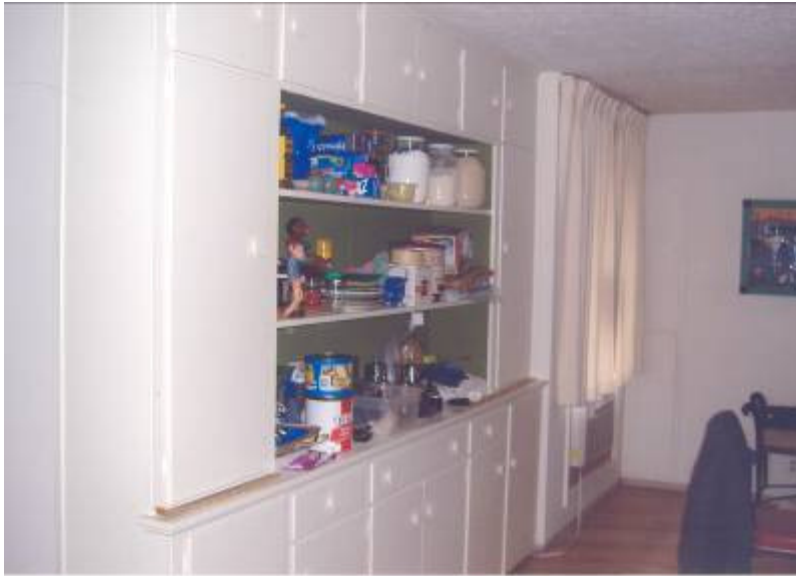
14. Close up of built-in cabinets and shelving looking southwest.

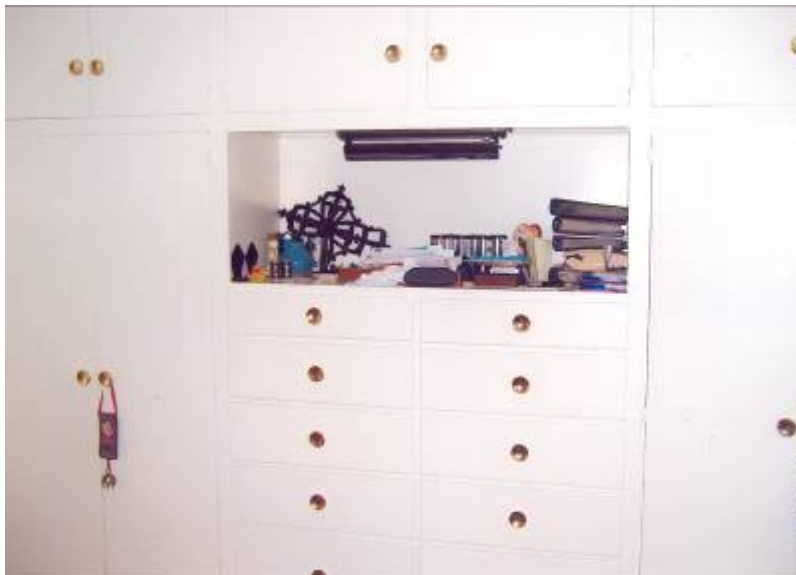
15. Close up of built-in cabinets and shelving in southwest bedroom looking east.

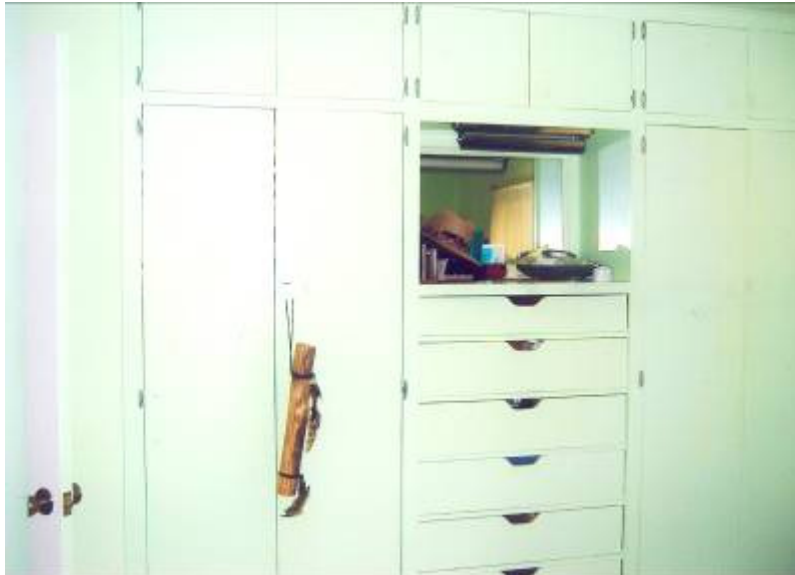
16. Close up of built-in cabinets and shelving in southeast bedroom looking north.

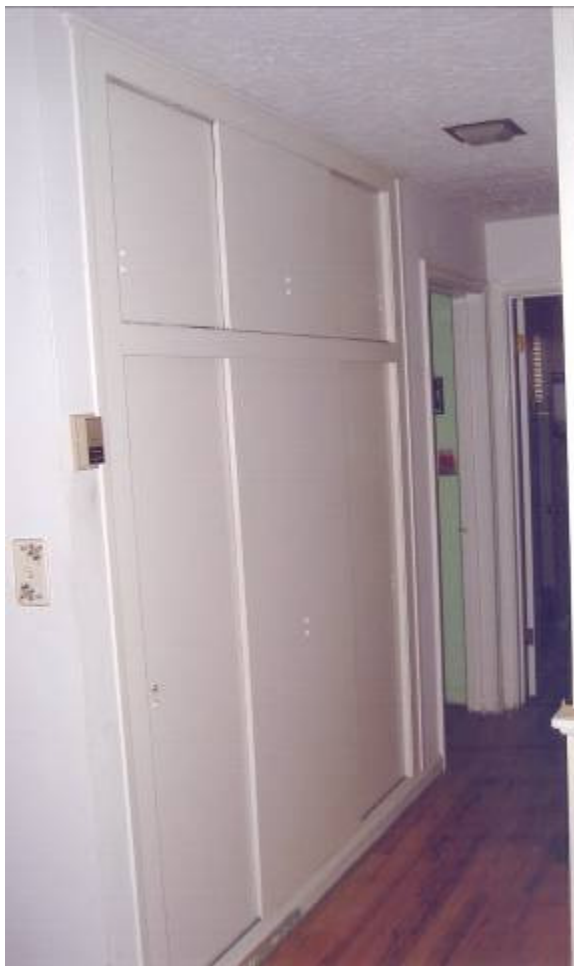
17. Close up of built-in cabinets and shelving in hallway, taken from living room looking south.
